Western Downs Regional Council Flood Review and Management Study

Stage 1 Report – Flood Review February 2013

Title :	Western Downs Regional Council - Flood Review
Author :	Barry Rodgers / Jo Tinnion
Synopsis :	Catchment understanding and summary of Summer 2010/2011 flood events

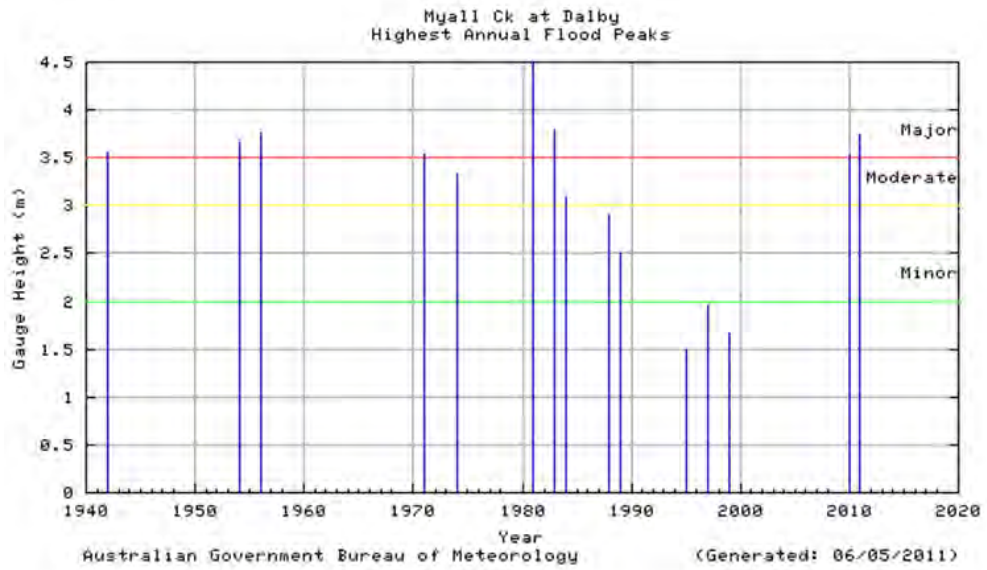
The largest flood on record occurred in 1981 reaching a gauge height of 4.5m resulting in 700 homes and 140 businesses being inundated and damage to 25,000 ha of agricultural land. Figure 2-3 illustrates the flood heights in Dalby.

Figure 2-3 Recorded Flood Heights in Dalby (reproduced from BoM)

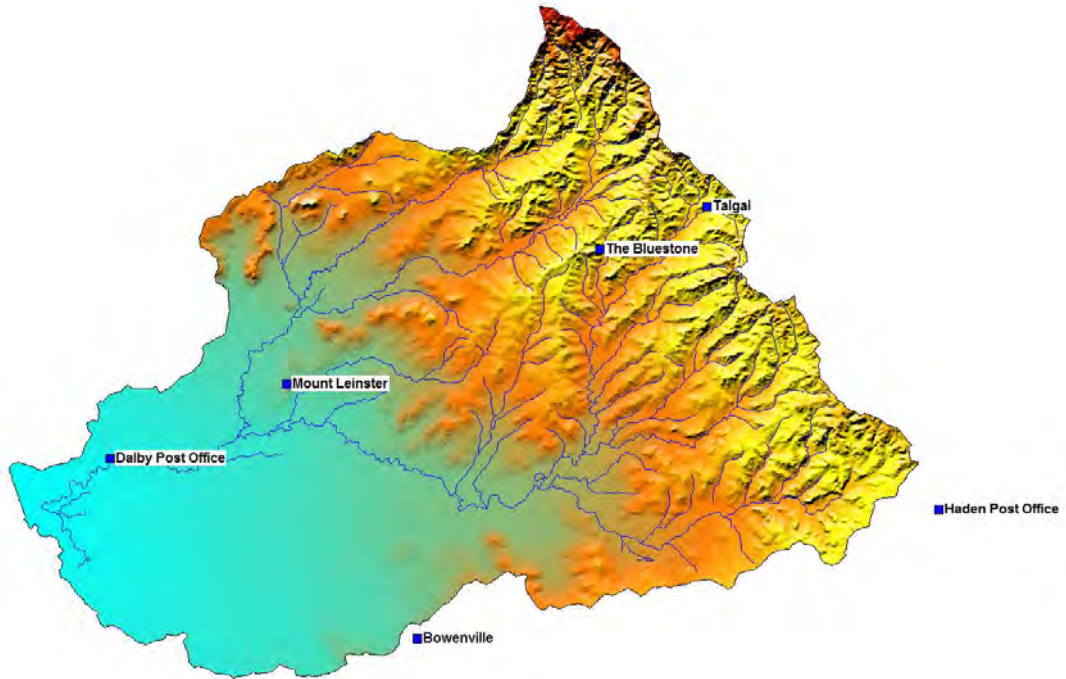
Figure 3-2 Selected Daily Rainfall Gauges – Myall Creek Catchment

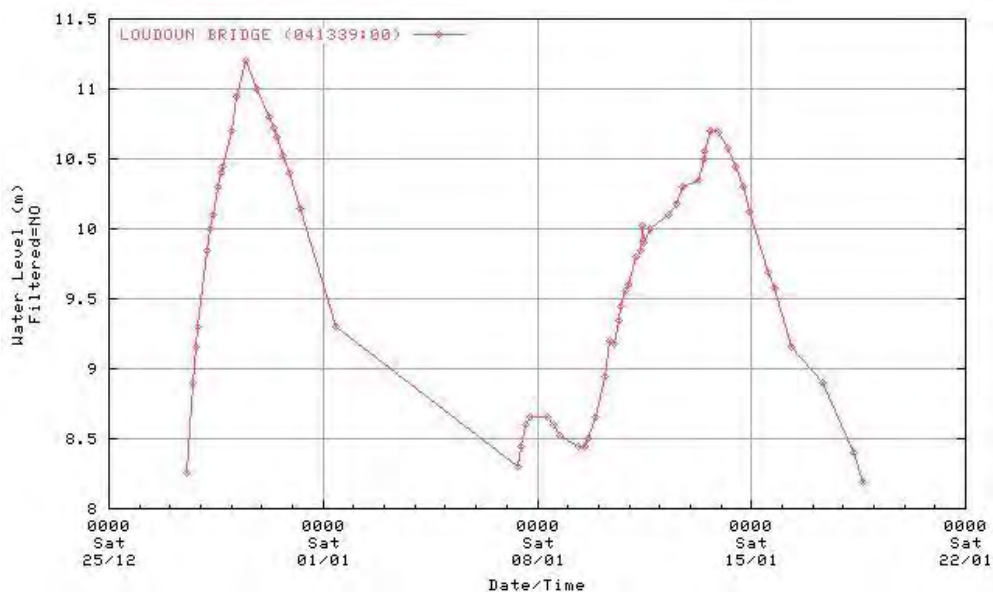
Figure 3-4 River Condamine at Loudoun Bridge near Dalby

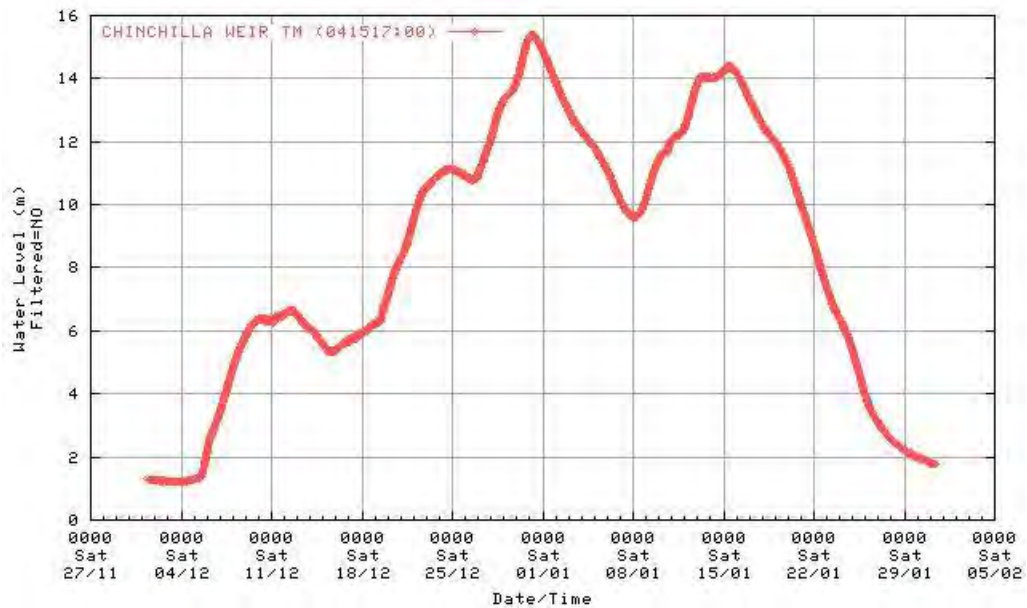
There were two separate flood events that impacted Chinchilla, one on 28 December 2010 and the second on 12 January 2011. Hydrographs clearly showing two events are provided in Figure 3-5 and Figure 3-6 for Charley’s Creek and the Condamine River respectively.

Figure 3-6 Condamine at Chinchilla Weir Flood Levels (Dec 2010 – Jan 2011)

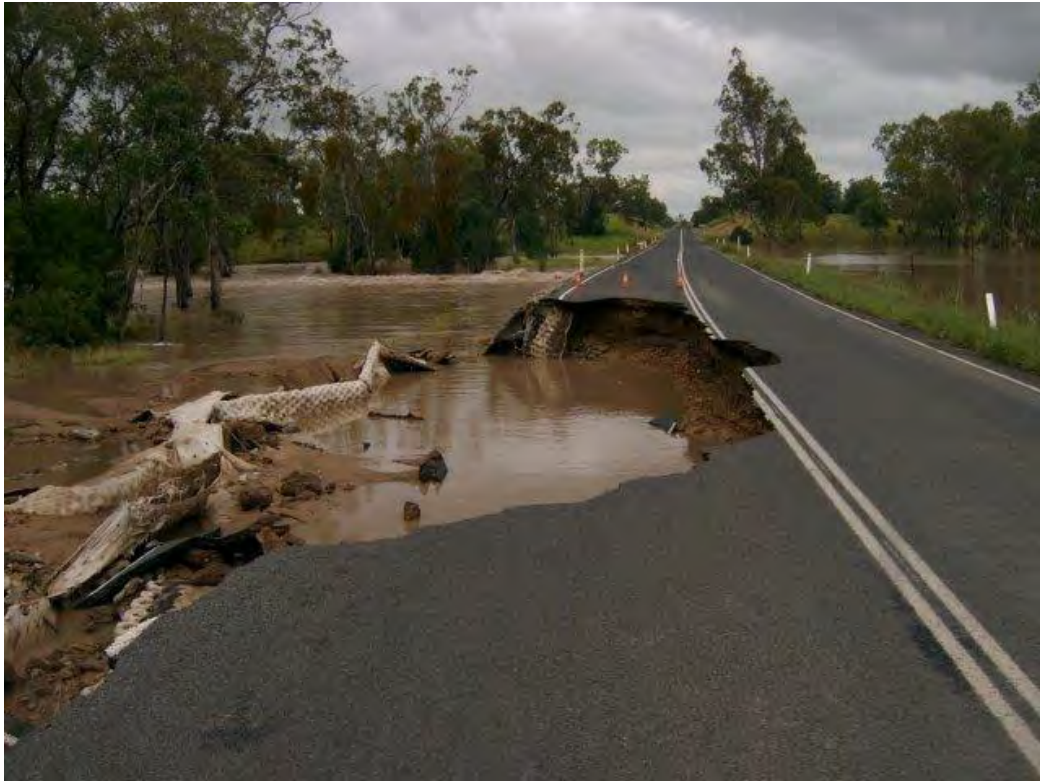
Wandoan was largely spared from any direct flood damage during summer 2010 / 2011 flooding to property but suffered the secondary effects of isolation with the main Leichhardt Highway being cut both north and south of the town preventing travel to Taroom and Miles respectively. Once floodwaters receded a complete section of the highway north of Wandoan was revealed as being washed away.

Figure 3-7 Flood Damage to Leichhardt Highway North of Wandoan

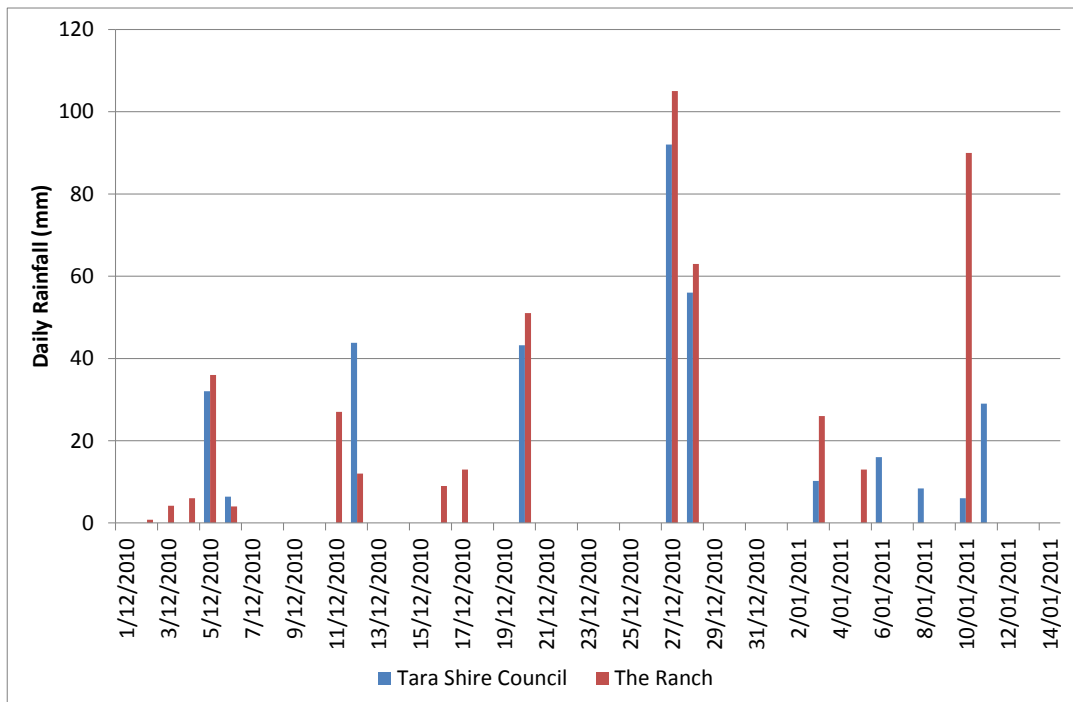
Figure 3-8 Tara – Recorded Rainfall Over the Undulla Creek Catchment

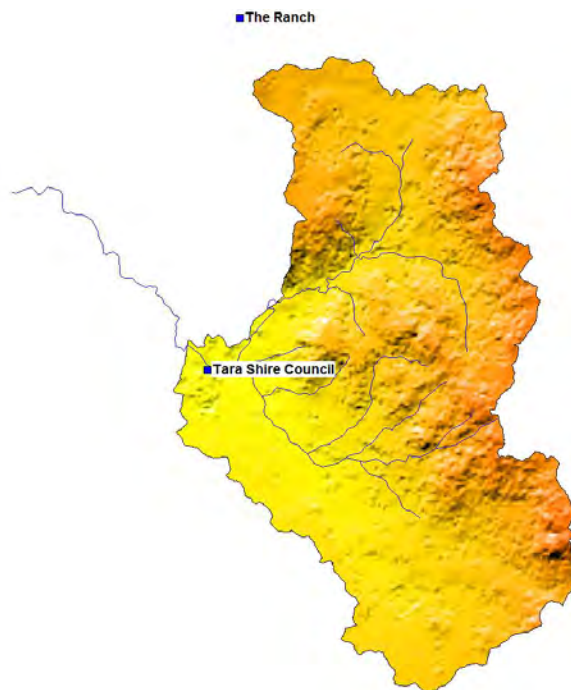
Figure 3-9 Selected Daily Rainfall Gauges – Undulla Creek Catchment

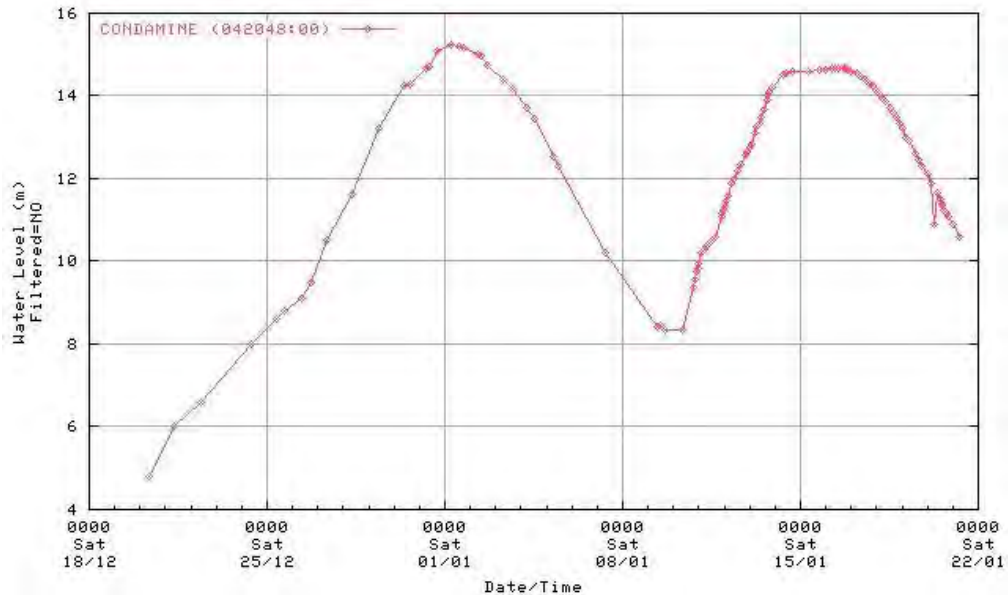
A double peaked hydrograph was tracked along the Condamine River system and fed by inflows from major tributaries. A hydrograph of water levels is shown in Figure 3-12 in which the two peaks can clearly be distinguished. The double peak led to the town of Condamine being affected by two flood events.

Figure 3-12 Flood Peaks on the Condamine River at Condamine (Dec 2010 – Jan 2010)

The first peak occurred on 1 January 2011 resulted in the first mandatory evacuation of Condamine on record, with residents evacuated to Dalby on 30 December 2010 by helicopter before the flood waters from the Condamine River encircled the town. The peak flood height recorded on 1 January was 15.25m measured at the Condamine gauge which represents the highest recorded level ever, surpassing the flood of 1942. It resulted in the inundation of 42 homes and 12 businesses. Evacuated residents began returning to Condamine on 5 January 2011 as flood levels receded.

The second flood event occurred on 16 January 2011. The Condamine River rose to 14.67m, the second highest recorded level ever, resulting in 12 homes and seven businesses being flooded. Residents were evacuated for a second time as a result of this flood event. Every road in Condamine was cut by floodwater. The flooding caused the water treatment plant to be shut down and it wasn't until the end of February 2011 that water restrictions were eased for the residents.

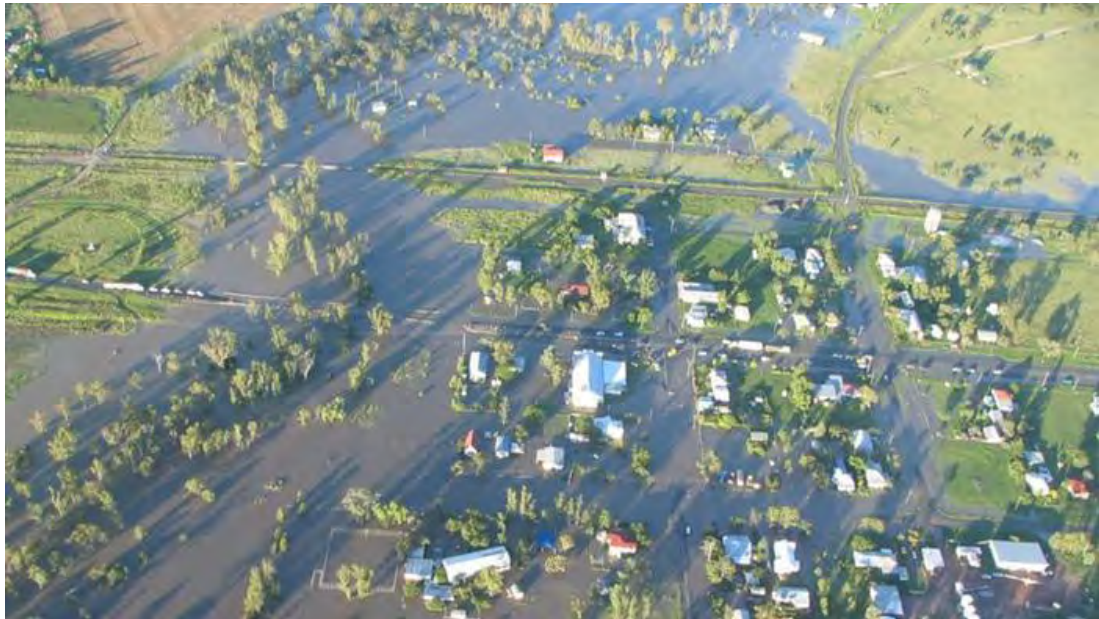
The first flood event occurred on the 28 December and an aerial image of this event through Warra is shown in Figure 3-13. It can be seen that a significant portion of the town was inundated.

Figure 3-13 Flooding in Warra looking Upstream (north), December 2010
